West Central Neighborhood's
Guide to Historic Character.

Department of Community
Development and Planning

City of Fort Wayne
Win Moses Jr., Mayor

AUGUST, 1982

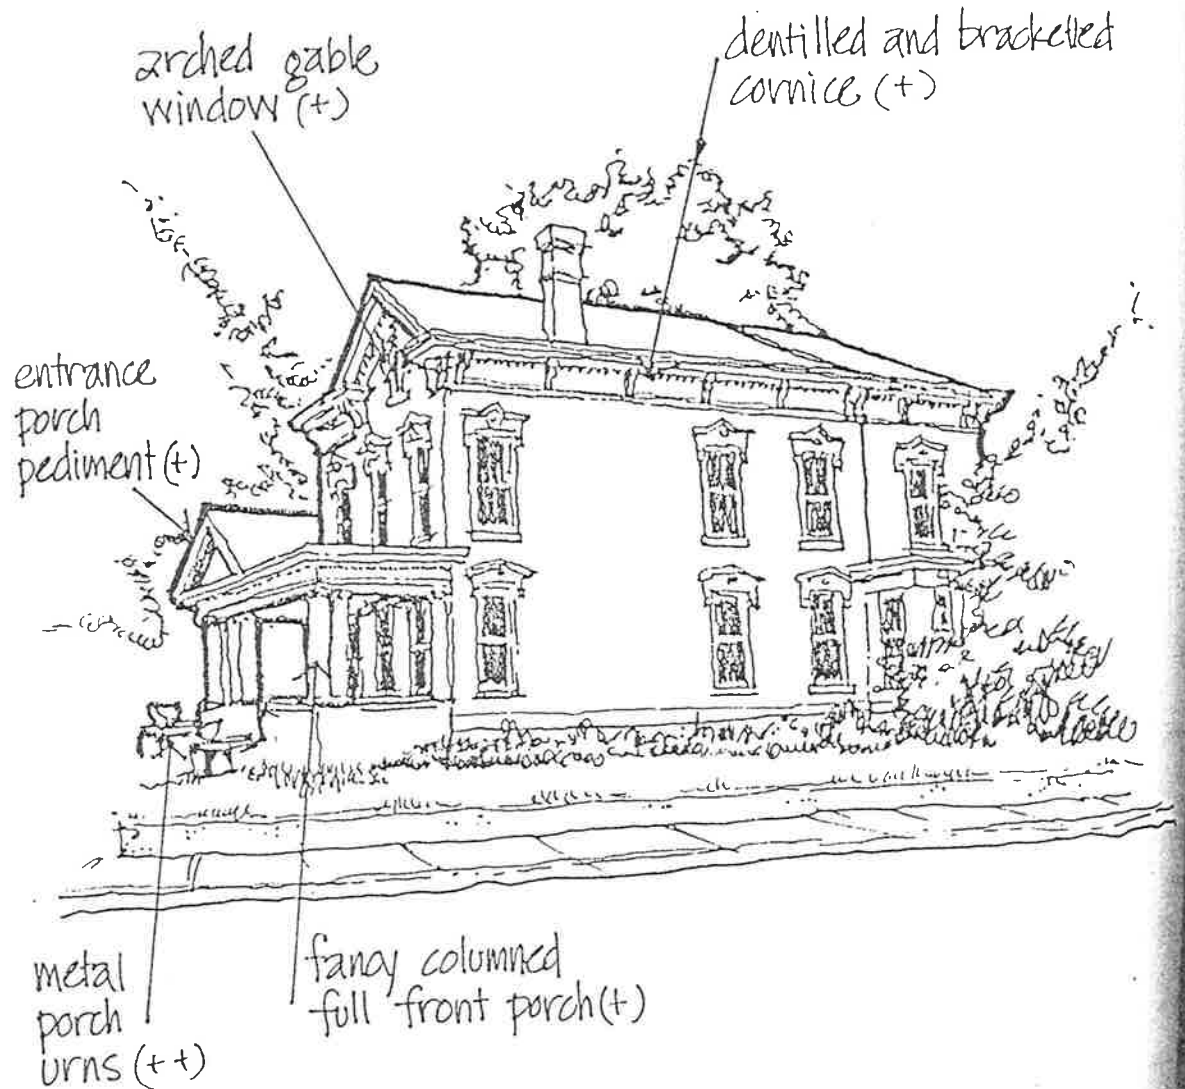
805 W. Wayne

COMMENTS: The ivy should be removed from the brick work before it causes additional damage to the mortar joints. As it is, some tuck pointing is needed.

If the existing porch is not original, then it is a early addition and almost as old as the house.

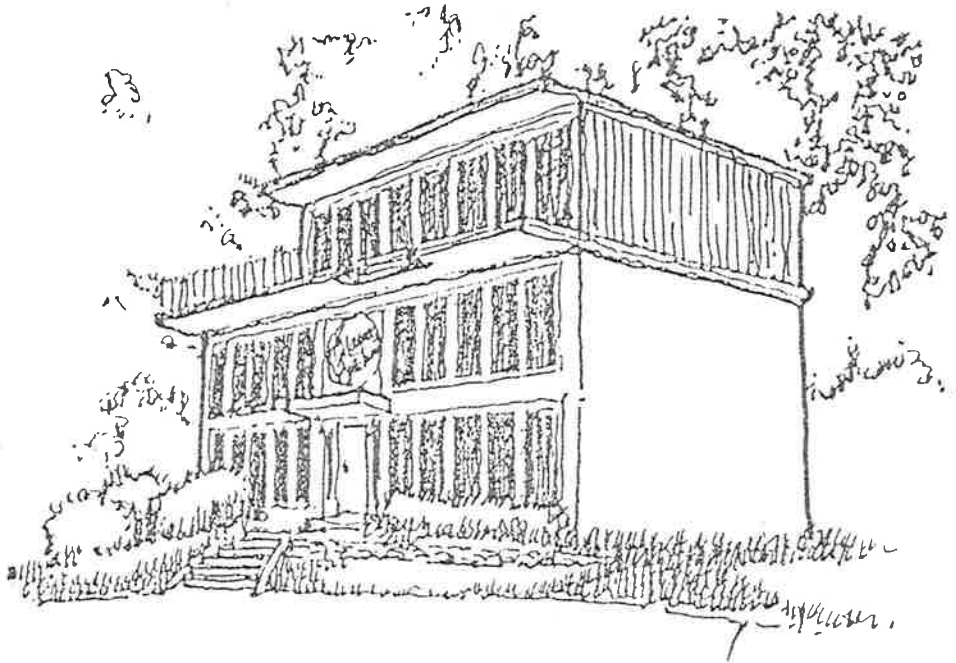
The Cottonwood Apartments (1950)

COMMENTS: This is an attractive, modern apartment house, but in the context of a historic neighborhood it should be subdued as much as possible. To help make it less obtrusive, an earthtone or subdued color scheme is important combined with a heavy planting of trees, shrubs, and vines. Plantings are especially needed on the south and west sides, as these are the most intrusive on the neighborhood. The sign over the door should either be replaced or made less commercial to be in better context with a residential area.

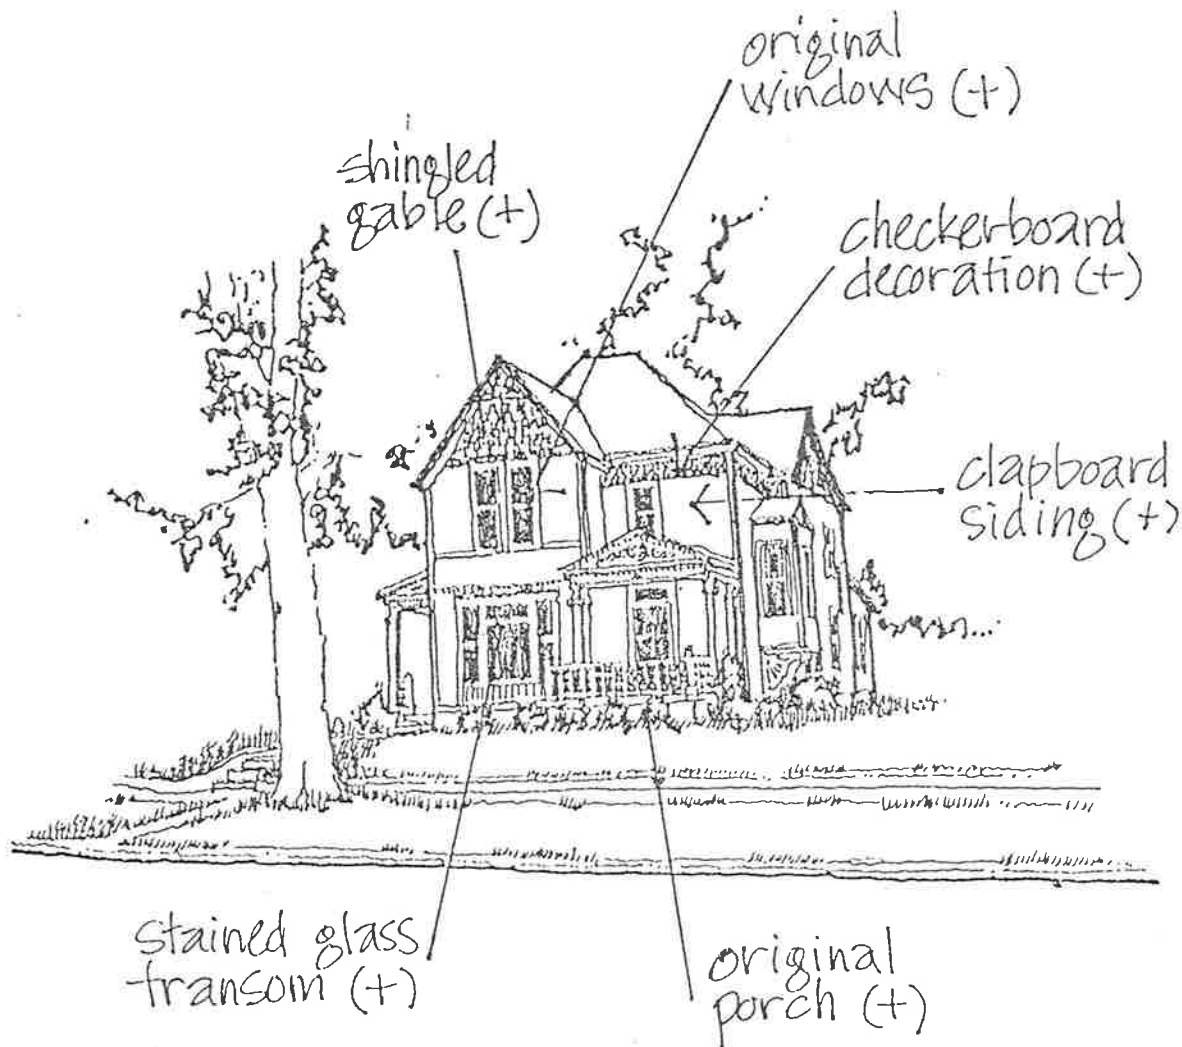
1116 W. Berry

The existing wrought iron porch columns are not consistent with the style and are too flimsy to visually support the porch pediment. If the columns are replaced, the replacements should match the classical columns on the side porch.

The owners have wisely retained the original clapboard siding.

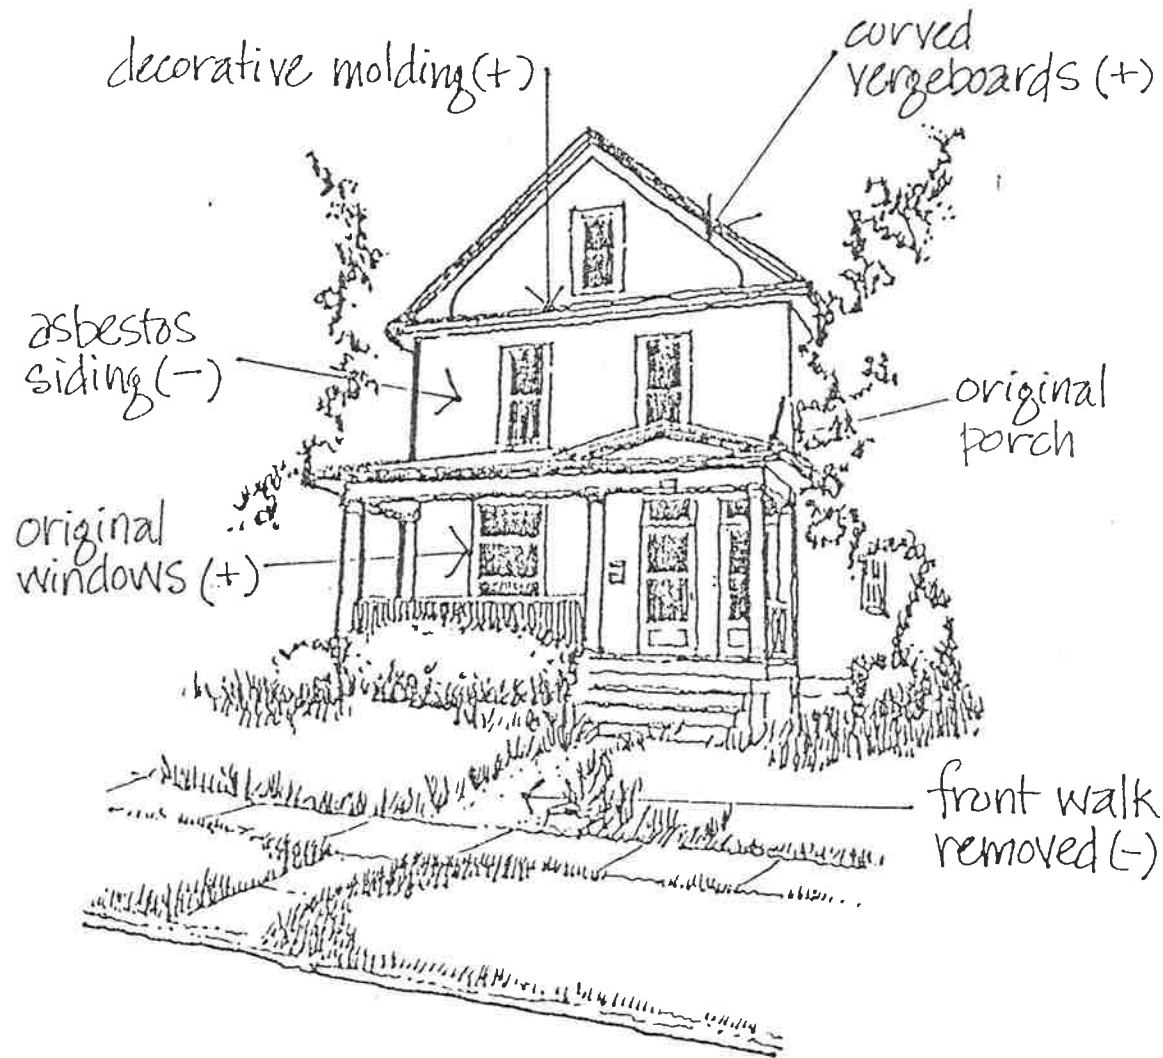
1241 W. Berry

COMMENTS: The front porch originally appeared like the one on 1239 W. Berry. The boxed railing and piers should be replaced by turned spindles and slender classical columns.

Most of the trim and detailing on this house is either covered up or has been removed. This house could be very attractive with the restoration of these basic elements and a good paint job.
